Re: Bay State Gas Company d/b/a Columbia Gas of Massachusetts – D.P.U. 19-140  
Compliance Agreement Consent Order Requirements (15) and (22)

**COLUMBIA GAS OF MASSACHUSETTS’ STATEMENT IN SUPPORT OF  
A FINDING OF CRITICAL ENERGY INFRASTRUCTURE INFORMATION**

**Incident Review**  
**4/16/2019, South Main St., Palmer - Excursion**

## Low Pressure System Outage

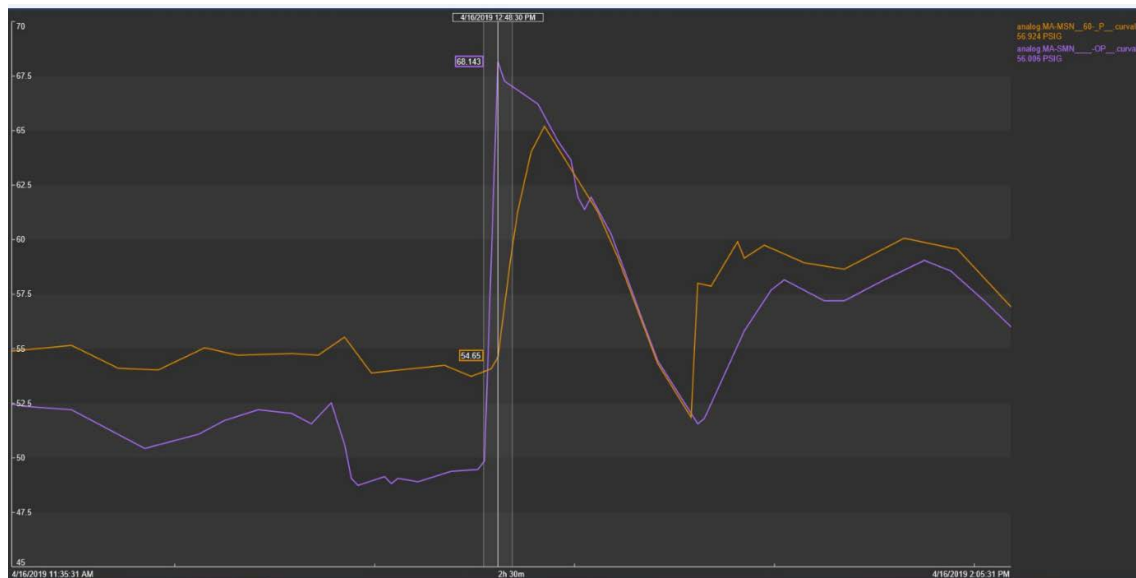
**Figure 1: SCADA TREND 4.16.19 Palmer and Monson Stations**

- The Leader of M&R received a call from Gas Control at 12:49 with regard to pressure at Palmer Station. Palmer HIHI reading was at 68 psig; Monson HIHI reading was 56 psig. The M&R Leader starting calling in other M&R technicians.
  - 12:50 called Maintenance Mechanic M&R technician (Doherty) to head to Palmer.
  - 12:51 called Maintenance Mechanic M&R technician (Clement) to return to Palmer.
  - 12:57 called Gas Control, informed them the technicians on their way and thought technician may have shut off incorrect valve.
  - 13:03 notified System Operations Manager.
  - 13:20 pressure back to normal.
  - 13:24 called M&R Specialist to site to confirm pressure readings.
  - 16:00 Maintenance Mechanic M&R technicians sent for drug test.

- Gas Control received an alarm at 12:48 at S. Main St. Palmer. Pressure reading was at 68.15 psig. Gas Controller called M&R Leader at 12:49. At 12:50, Gas Control received Hi pressure alarm at Monson Line and a HIHI pressure alarm at 12:51. At 12:57, M&R Leader called into Gas Control to inform them that the M&R technician (Clement) was at the station prior to the alarms. At 13:06, HIHI pressure alarms cleared at both stations. At 13:08, Hi pressure alarms cleared at both stations - See Figure 1. Figure 2 depicts the Activity Report maintained by the Gas Control group for the incident.

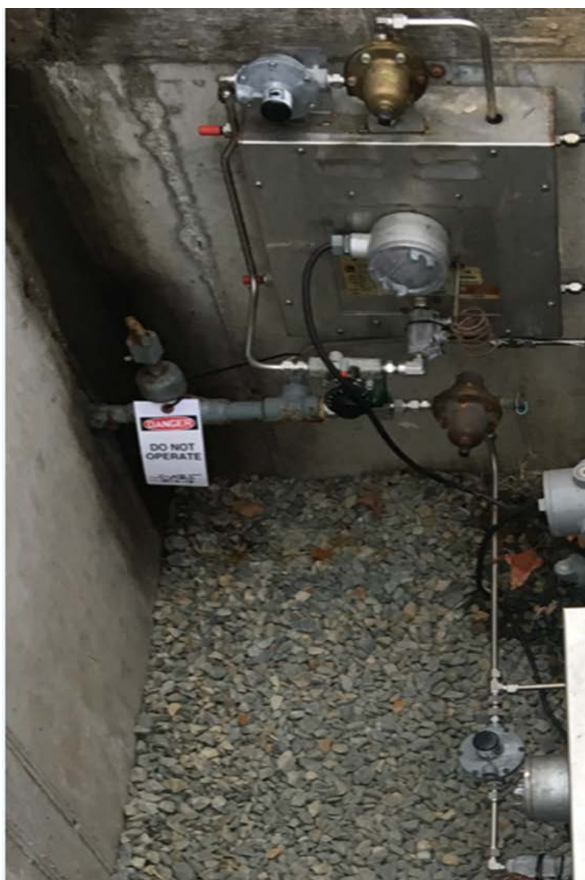
**Figure 3 – New “Do Not Operate” Tag**

**Conclusion:** The technician shut off a valve clearly identified, “DO NOT OPERATE”. See Figure 3 for picture of new Tag installed on 4/16/2019 by Maintenance Mechanic M&R Technician, because the old tag was dirty but still legible. While there is no known standard operating procedure governing “Do Not Operate” tags, such failure to recognize the risk of turning the valve in light of the “Do Not Operate” tag was a root cause of this situation. Technician failed to follow Gas Standard 1750.010-MA (1/17/2019) and Gas Standard 1170.040 (1/1/2018) in regards to notifying Gas Control before and after performing work at a station. If Gas Control had been notified there would have been more visibility, and the situation may have been mitigated. On 4/19/2019 a revision to GS 1750.010 was published no longer requiring a call to Gas Control unless work is performed on monitored or controlled equipment. The effective date of the revised gas standard is 4/12/2019. The due date in LMS for the review of the change to the standard is June 30, 2019.

The station design as well as the use of the monitor regulator at the 58 psig set point did not keep the downstream pressure below the MAOP plus the 10% allowable build up permissible pursuant to the regulations. While the monitor regulator worked to mitigate the downstream impact, the set point of the monitor regulator, the reaction time before it lowered pressure, as well as the station configuration all contributed to the pressure excursion since the system as a whole did not adequately compensate for human error.

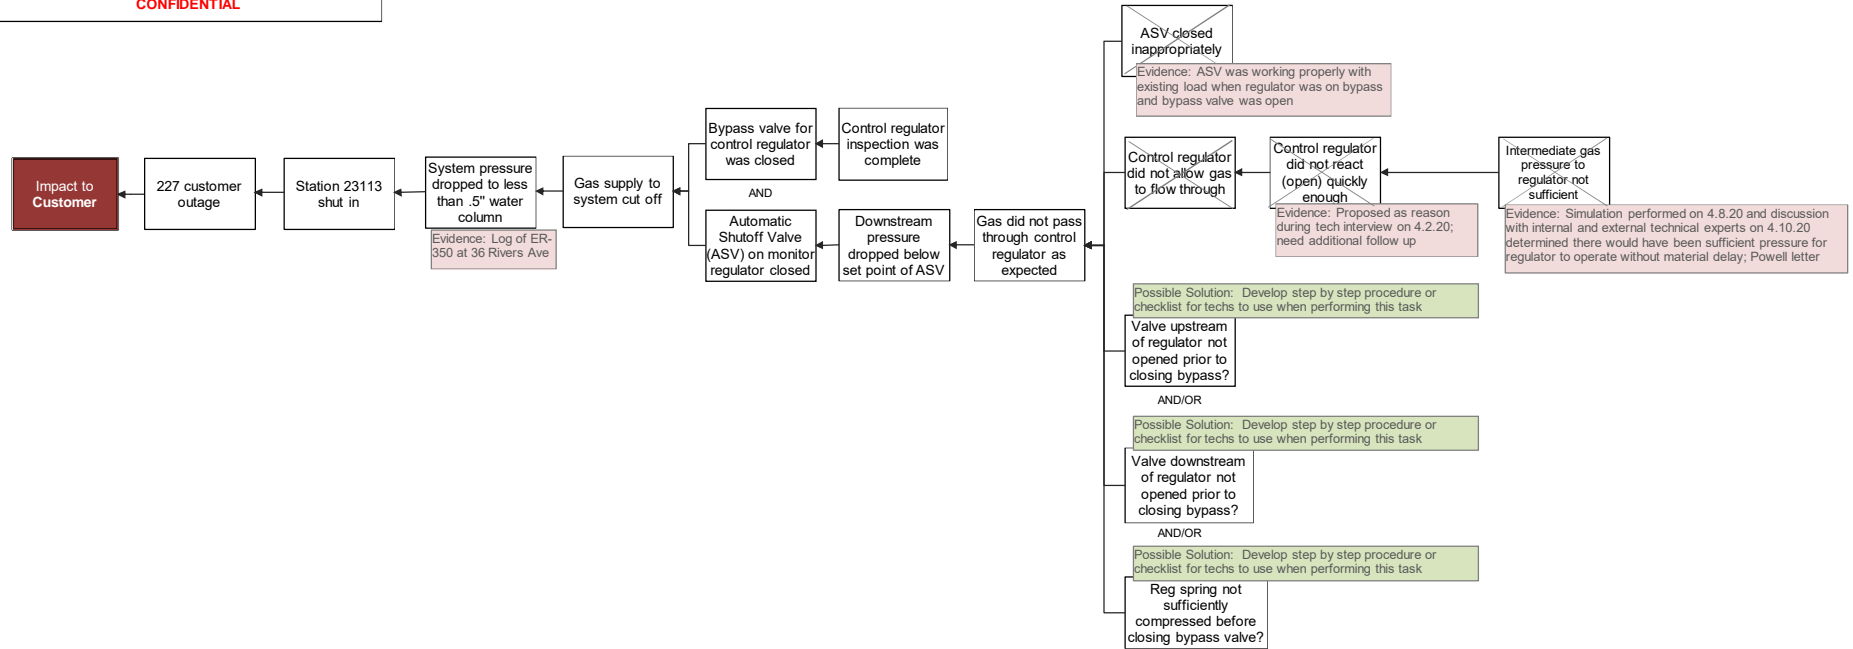
Inadequate Process / Procedure – No detailed checklist for performing this maintenance activity

Operator Error - Failure to properly bring the control regulator back into operation

In an effort to understand why gas did not flow through the control regulator as expected, the Company interviewed the technicians who performed the work. The technicians indicated that the control regulator did not allow gas to flow through because it did not react (open) quickly enough. The technicians believed that the cause was insufficient intermediate gas pressure to allow the control regulator to function properly.

- 1) Inadequate process / procedure - *No detailed checklist for performing this regulator maintenance activity.*
- 2) Operator Error – *Failure to properly bring the control regulator back into normal operation.*
