Overpressurization of Natural Gas Distribution System, Explosions, and Fires in Merrimack Valley, Massachusetts September 13, 2018

Accident Report

NTSB/PAR-19/02
PB2019-101365

Pipeline Accident Report

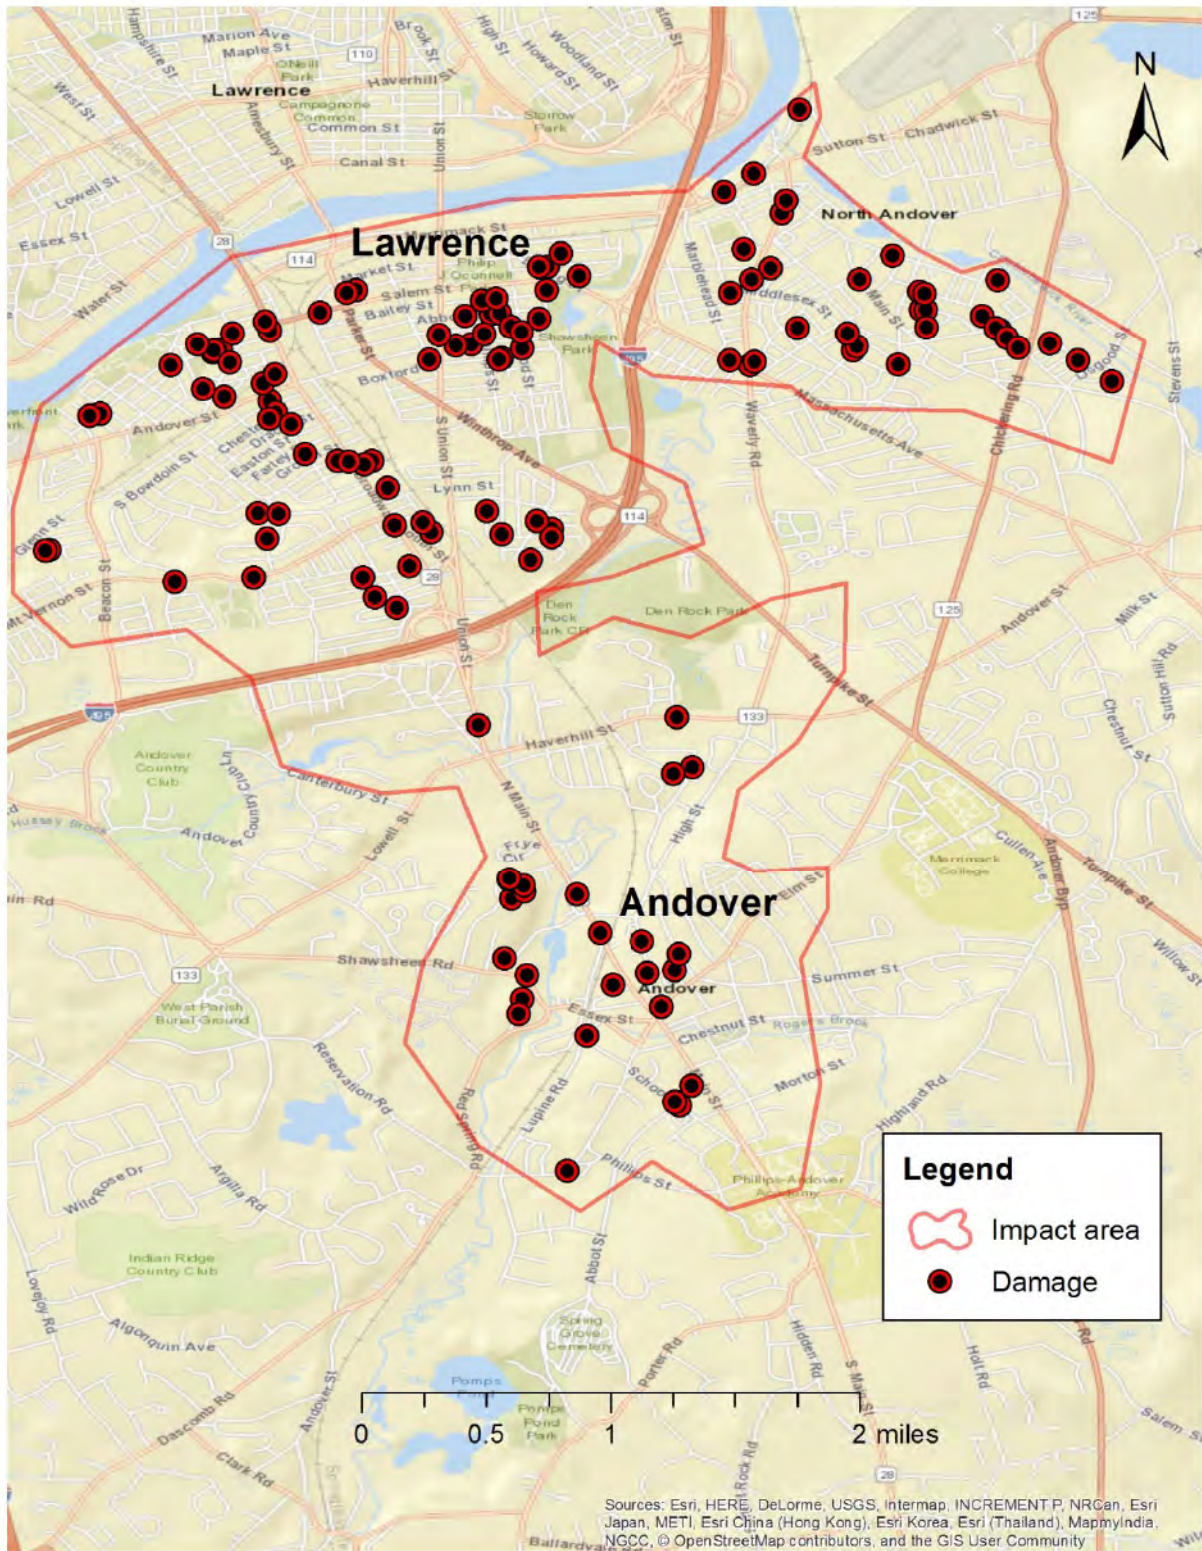
Figure 1. Map of the damaged structures in the area impacted by the overpressurization.

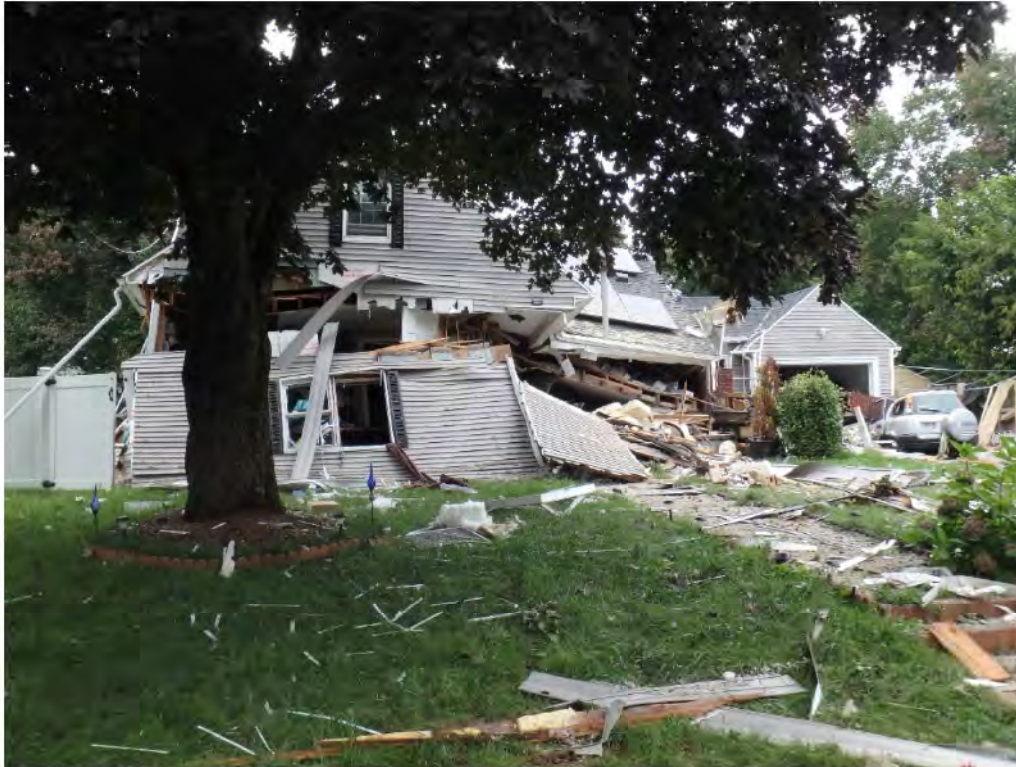
An 18-year-old male was killed when a home exploded, and the chimney fell onto the vehicle where he was sitting. (See figure 2.) Another person in the vehicle at the time of the

Figure 2. Remnants of house where the fatality and two severe injuries occurred.

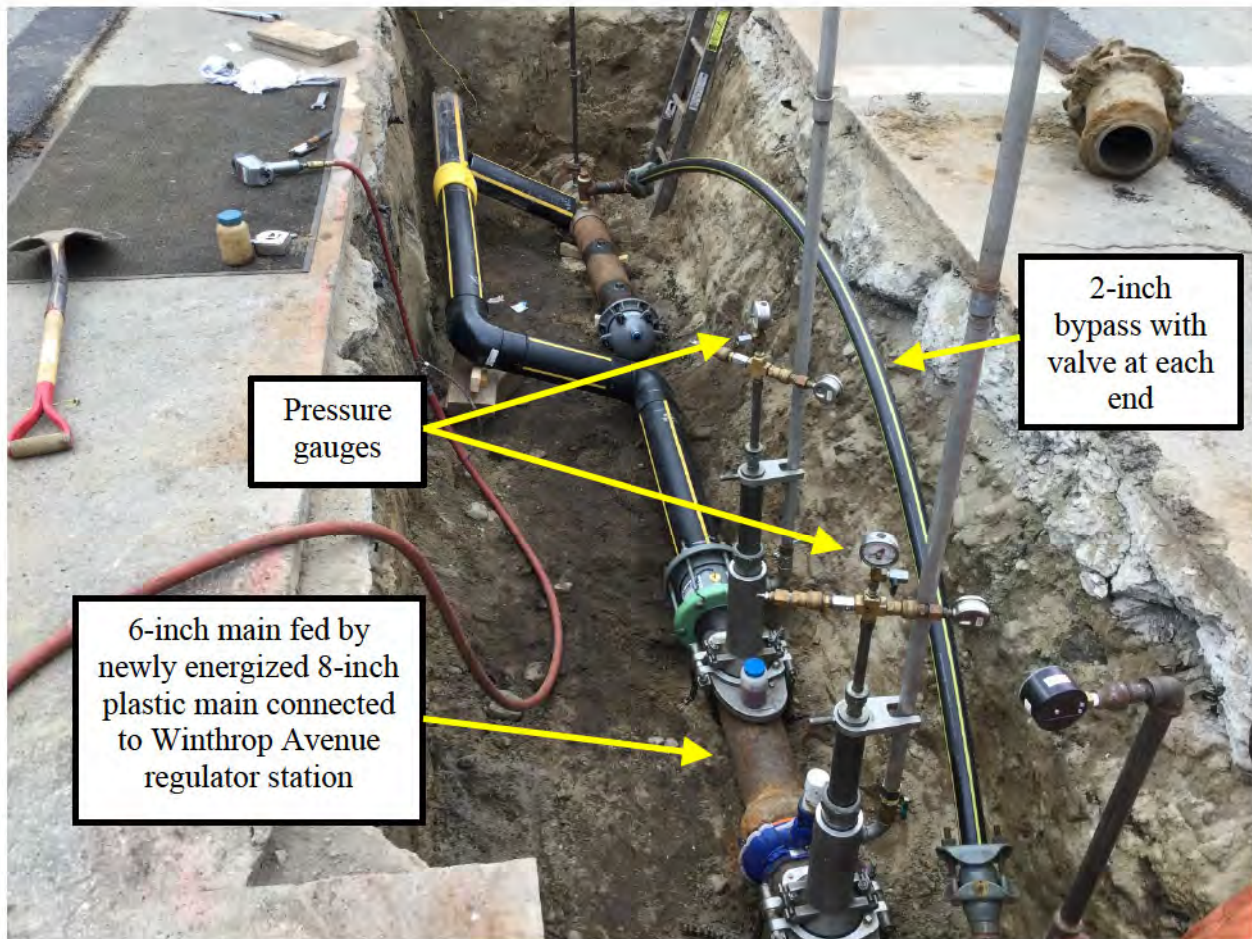
valves on a 2-inch plastic bypass pipe between the cast iron and polyethylene mains.⁸ The crew then cut the bypass pipe to abandon the cast iron main. (See figure 5.) In postaccident interviews, crewmembers said that within minutes of closing the valves and cutting the bypass, they observed the pressure gauge on the polyethylene main exceed the expected readings.⁹ Furthermore, a fitting on the polyethylene natural gas main blew off into the hand of one of the workers. The crewmembers said that they responded quickly to plug the blowing natural gas, and they heard emergency vehicles in the neighborhood and observed smoke plumes in multiple directions within minutes.

Figure 5. Salem Street tie-in for the South Union Street project (looking west). Photograph courtesy of Feeney Brothers.

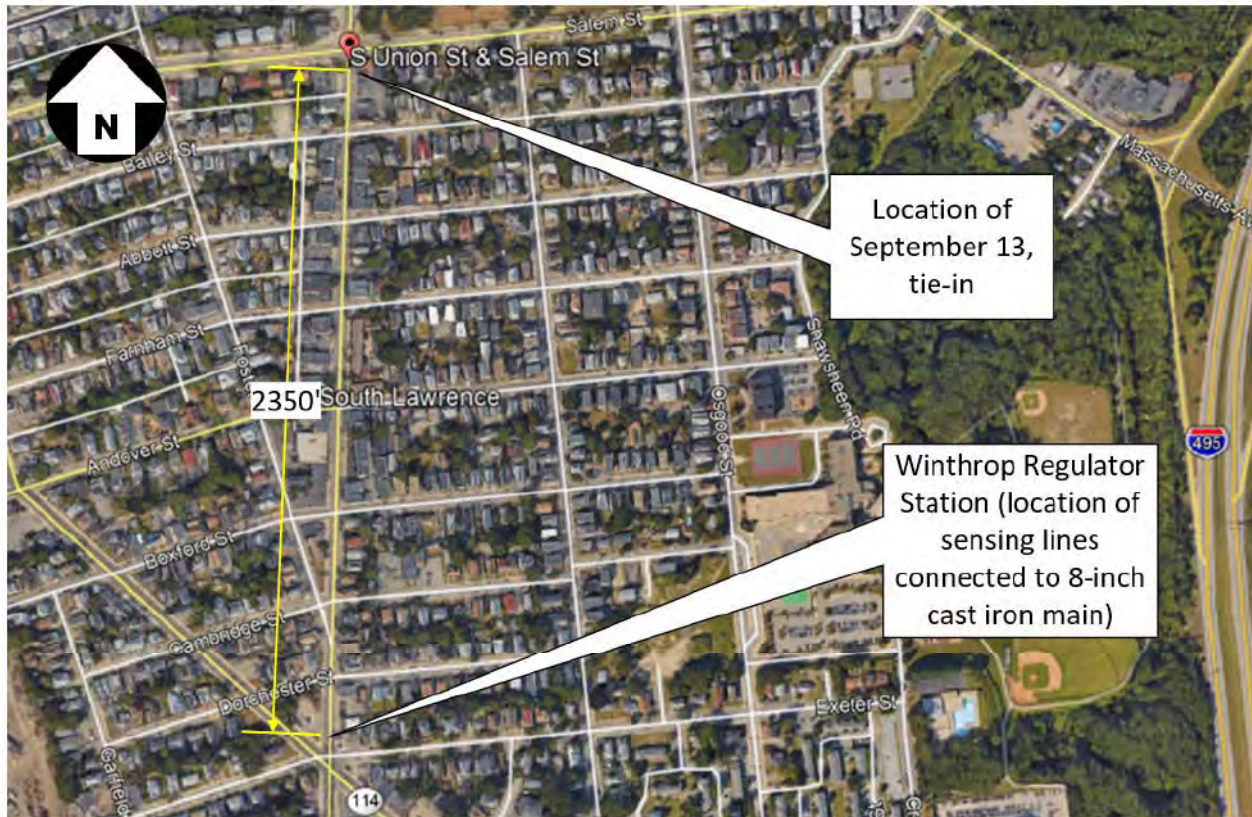
At the Winthrop Avenue regulator station, about 0.5 mile south of the work area, the abandoned cast iron main was still connected to the regulator sensing lines providing input to the two pressure regulators used to control the system pressure.¹⁰ (See figure 6.) Once the contractor

crew isolated the cast iron main, the natural gas pressure began to drop in the cast iron main and in the regulator sensing lines. As the pressure dropped, the pressure regulators responded by opening further, increasing pressure in the natural gas distribution system. Since the Winthrop Avenue regulators no longer sensed system pressure, they fully opened, allowing high-pressure natural gas to be released into the low-pressure natural gas distribution system.

Figure 6. Location of September 13, 2018, tie-in and the Winthrop Avenue regulator station.

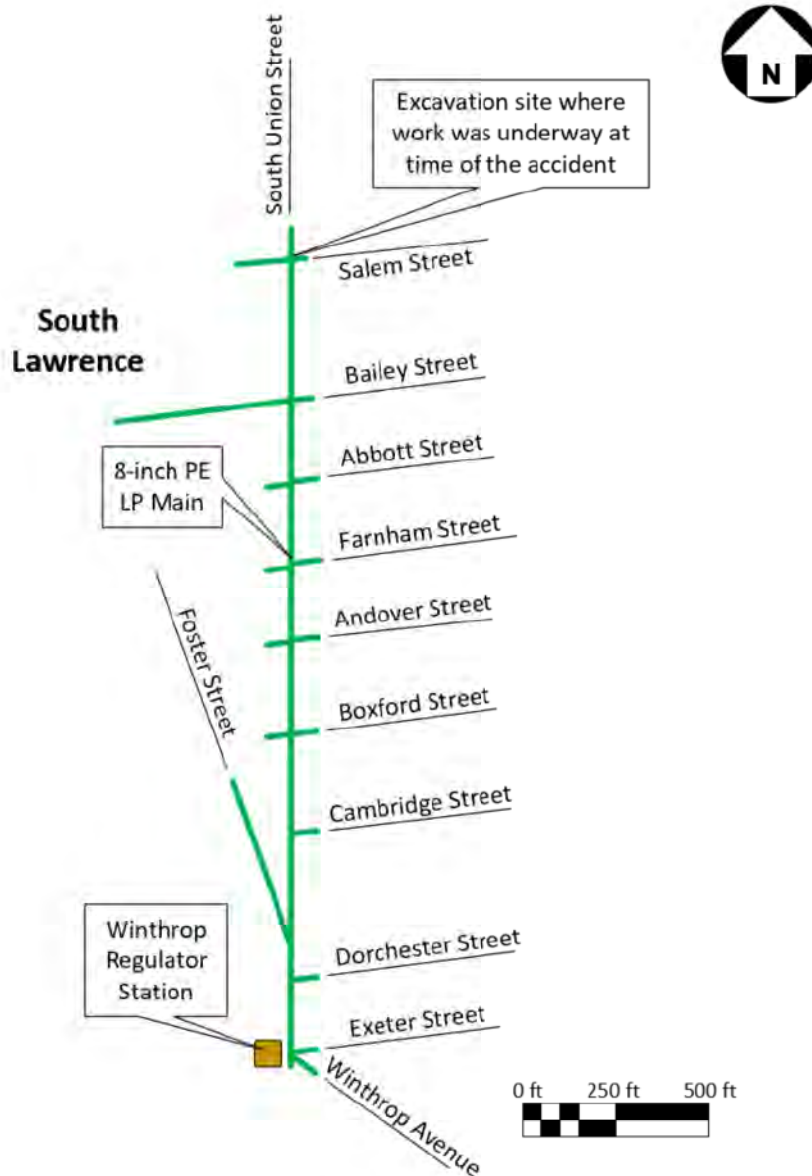
Figure 7 shows the area of the replacement of the natural gas main in South Lawrence along South Union Street with the cross-street tie-ins. The work on the day of the accident was at the north end of the project at Salem Street. The Winthrop Avenue regulator station is at the south end of the project.

Figure 7. Areas along South Union Street with tie-ins impacted by the project.

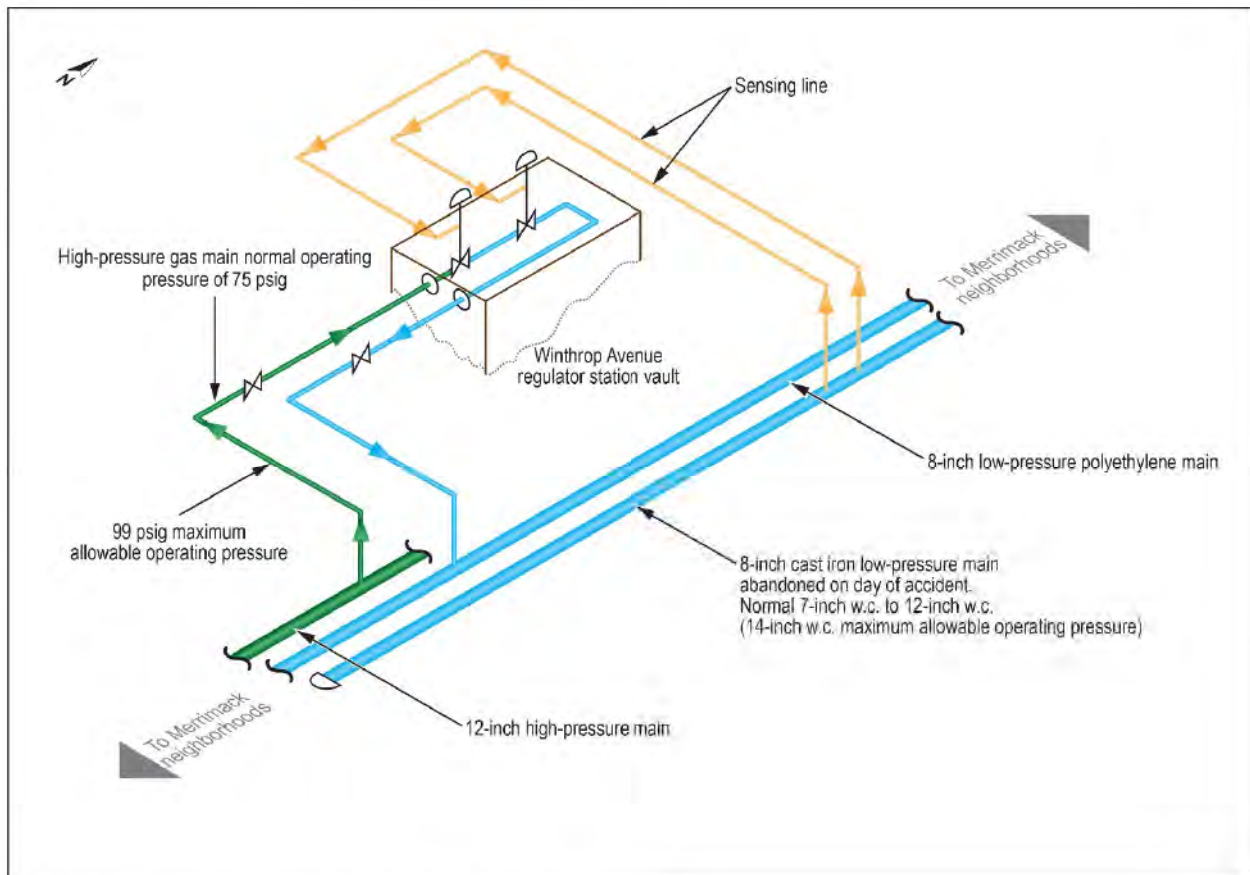
The first stage of the project involved the installation of the polyethylene main, which was completed in late 2016. The regulator sensing lines at the Winthrop Avenue regulator station remained attached to the cast iron main, where they controlled natural gas flow through the

Winthrop Avenue regulator station into both the cast iron and polyethylene mains, which were connected in the low-pressure natural gas distribution system. (See figure 8.)

The city restrictions, due to paving in the area, delayed the South Union Street project for more than a year. Prior to the delay, CMA connected the polyethylene pipe to the distribution system, which allowed it to be monitored for pressure changes. The second stage of the project began in 2018 and involved installing the tie-ins to the polyethylene main and abandonment of the cast iron main. On the day of the accident, the sensing lines were still connected to the cast iron main and were functionally disconnected from the distribution system when the cast iron main was abandoned.

Figure 8. The Winthrop Avenue regulator station.
