SERVICE LINE RECORD (SLR)

JOB ORDER # 20-8311115-00 FORM COMPL BY: 122461 CONSTR COORD: D. Williams
 NEW REPLACE ABANDON REPAIR SURVEY TIE-OVER/RECONNECT DATE: 08/21/20

SERVICE ADDRESS <u>35 Essex St</u>					CITY <u>Audover</u>					TERR <u>01400</u>			
PSID/SITE ID <u>870725009</u>		MT <u>-</u>	MASTER TAP REF (ADDR &/OR PSID/SITE ID)			CURB BOX LOCATION <u>21 RFB</u>		TAP LOCATION <u>29 RFB</u>		OR PRESS <u>HP</u>			
MAIN TO PROPERTY LINE OR CURB VALVE	LENGTH <u>8'-6"</u>	SIZE <u>010</u>	MATL <u>P</u>	DEPTH (IN) AT INSTALL <u>26</u>	OP PRESS <u>HP</u>	DATE INSTLD/ABN <u>12/2018</u>	INSTALL MTHD <u>P</u>	CASING MATL	REPAIR DATE <u>08/21/20</u>	REPAIR KIND <u>REC</u>			
PROPERTY LINE OR CURB VALVE TO METER	LENGTH <u>20'-6"</u>	SIZE <u>005</u>	MATL <u>P</u>	DEPTH (IN) AT INSTALL <u>24</u>	OP PRESS <u>HP</u>	DATE INSTLD/ABN <u>12/2018</u>	INSTALL MTHD <u>PI</u>	CASING MATL	REPAIR DATE <u>08/21/20</u>	REPAIR KIND <u>REC</u>			
RETIRED PIPE (CMA ONLY)	LENGTH	SIZE	MATL	DATE INSTLD		DATE ABN		MAIN INFO (CMA ONLY)	MAIN SIZE-MATL <u>020/P</u>	NEW PIPE FTG INSTLD (CMA ONLY)	LENGTH <u>11</u>	SIZE <u>010</u>	MATL <u>P</u>

jo num: 20-8311115-00 loc num: 8400 ^{REDACTED} supervisor: 8410P PAGE

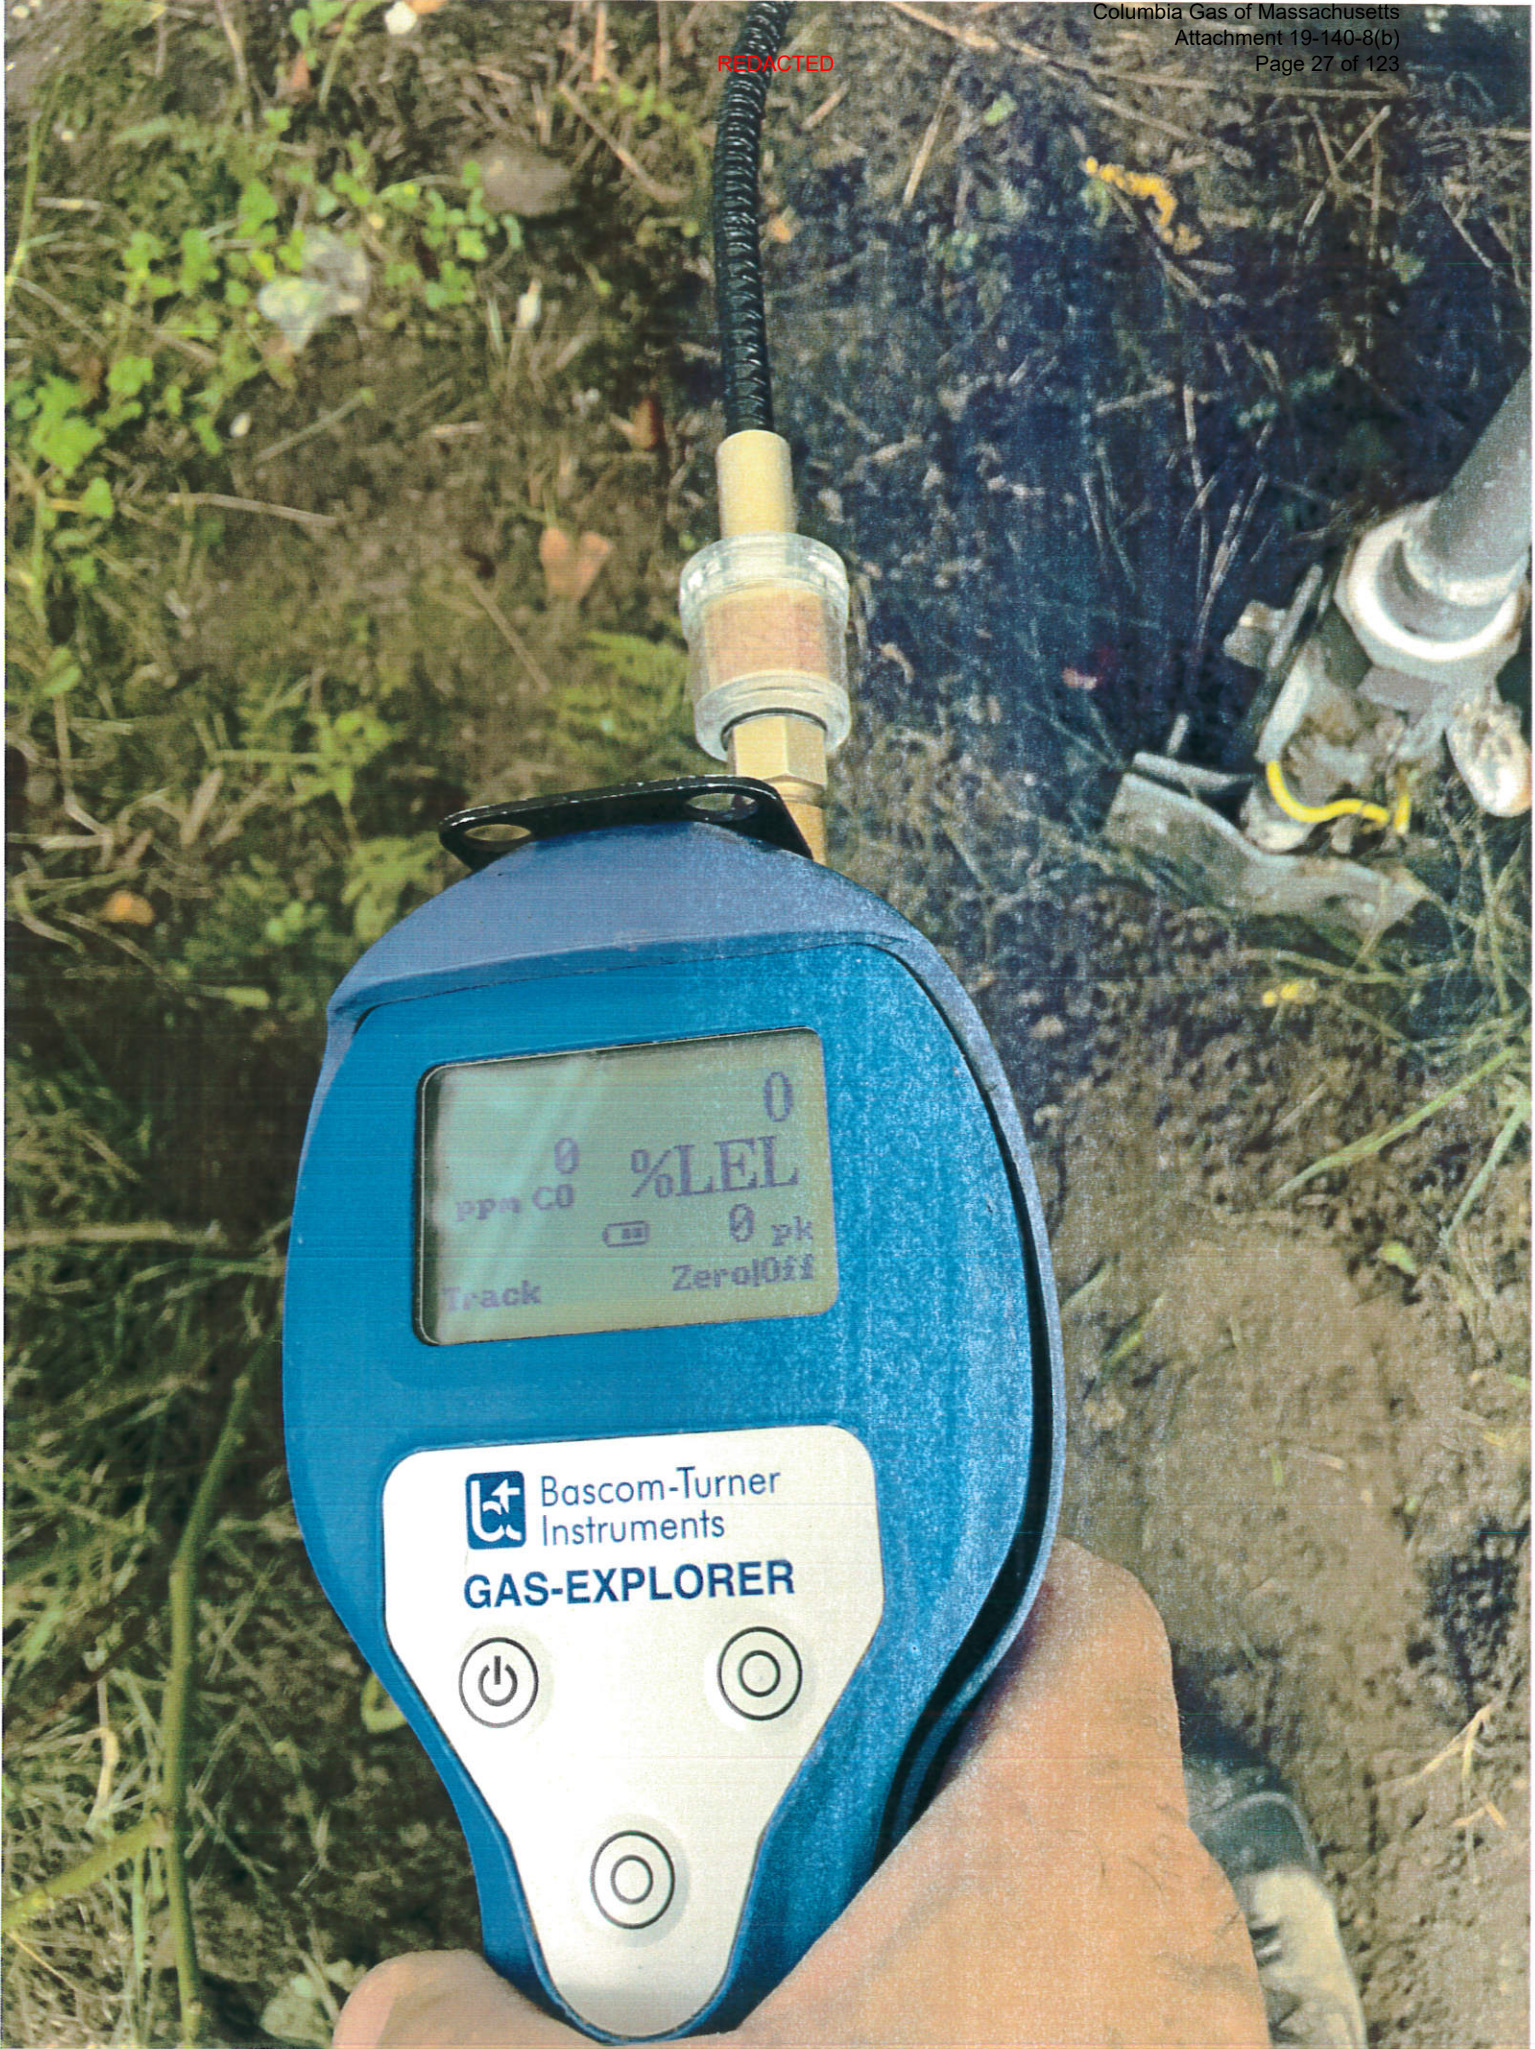
0 ppm CO
0 %LEL
Track Zero/Off
