D.P.U. 24-40 **Eversource Energy** 2023 Grid Modernization Report Attachment C Page 1 of 13

System Operation Post-Commissioning

Reliability Improvement

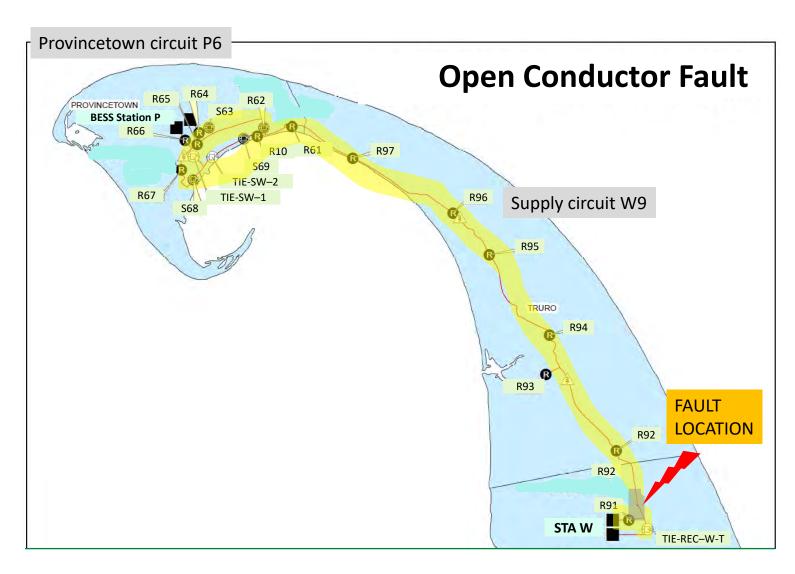
May 4, 2023

Fault – open phase conductor near source station W. Only 133 customers interrupted in fault area for 42 minutes while repairs were made.

Cause: Connector and single phase tap wire burnt open just beyond Station W

BESS Engaged automatically and carried all load for 42 minutes. No microgrid device operations needed.

Outage avoided for 9,917 customers across three towns.

BESS discharged from 94% to 81%

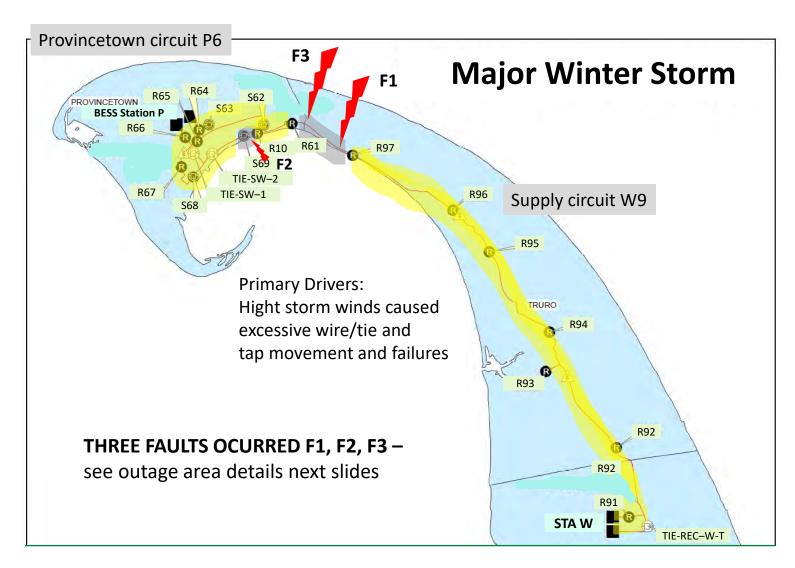
Dec 18, 2023

Fault #1 impacted 611 customers for 2 hours and 20 mins. (328 in Truro and 283 in Provincetown)

Cause: Wind and pole/wire movement caused broken tap and pole fire at 3 ph tap pole.

Recloser R97 tripped to isolate fault beyond it (dark area F1), Point of Common Coupling (PCC) R61 recloser opened on Direct Transfer Trip (DTT) to form island in Provincetown. Outage averted for 5,662 customers

BESS discharged from 95% to 73%

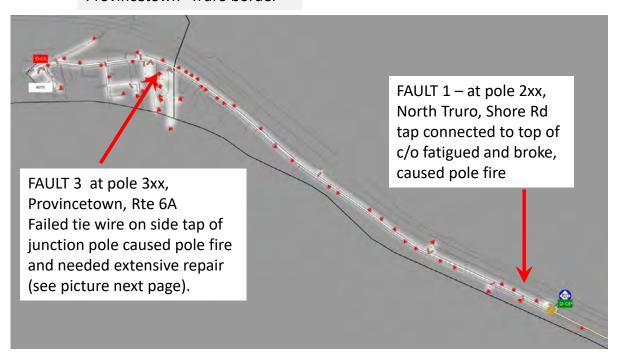
Provincetown -Truro border

Fault #3 impacted 611 customers for 6 hours and 49 mins. (328 in Truro and 283 in Provincetown)

Cause: Wind and pole/wire movement caused wire tie to fail and pole fire extensive damage

Recloser R97 tripped to isolate fault, PCC R61 opened on DTT to form island. Outage averted for 5,662 customers

BESS discharged from 95% to 28% Delays in synchronizing did not extend outage beyond 6 hr, 49 min repair time needed, but BESS SoC continued to drop.

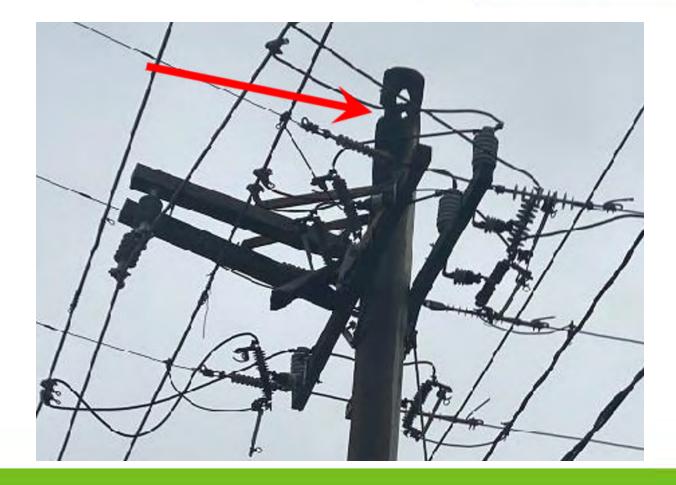
Near Provincetown – Truro Border

Fault #3 caused extensive damage

A failed tie wire on a side tap of 4-way junction caused loose tap and ground contact through pole. Appears that tap shorted to brace hardware and started pole fire.

Stormy conditions during fault and extensive damage required over 6 hours for crews to repair pole top.

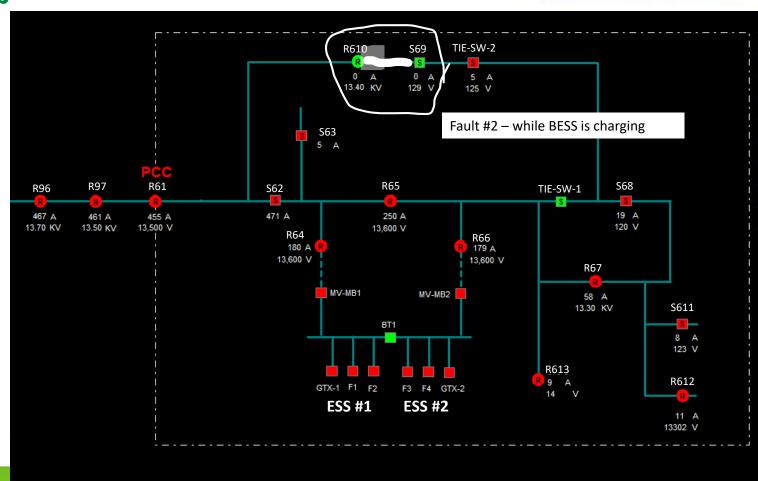
BESS Inrush Charging Current at 28% Soc Caused PCC R61 Recloser to Trip

- Up to 470A continuous
 on R61 to charge both ESS
 1 and 2 and carry all
 Ptown load.
- Inrush and load current was higher and believed to cause R61 to trip open.
- Interim solution was to charge only one ESS at a time until they were both at 50% SoC.
- Settings changes were needed to reduce charge rate when system is heavily discharged or provide Dispatcher guidelines to only charge one ESS at a time.

- 4. Appears that the BESS fast charging rates and moderate loading on line circuit P6 caused the R61 PCC recloser to trip when reconnected and charging at a 28% SoC.

- a. Evaluate and revise charging currents/rates to prevent unnecessary tripping.
 - b. Update Dispatcher instruction to allow for only charging one ESS at a time.

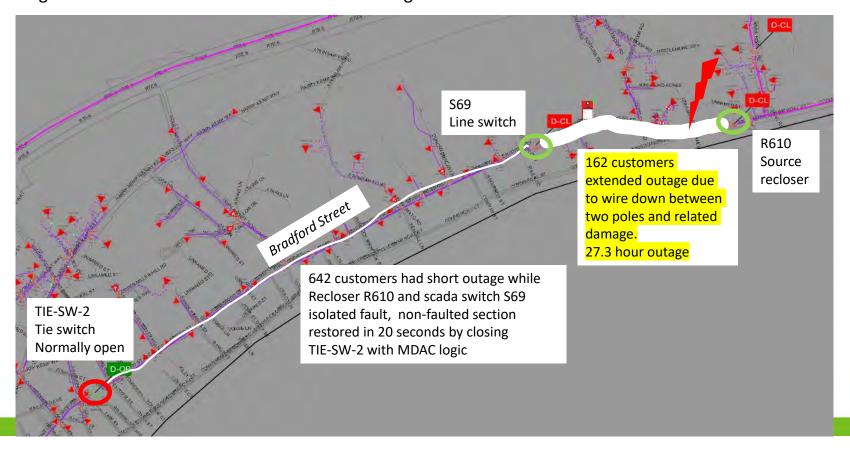
Fault #2: Circuit P6 wire down between S69 and R10

While the BESS was recharging, a primary wire down on Commercial St required recloser R610 to trip/reclose, and MDAC microgrid logic to isolate fault and minimize customer outage size in 20 seconds.

- b. On one P6 circuit smaller event, MDAC logic reduced outage time for 642 customers to 20 seconds. Impacted 162 customers for extended period of 27 hours until repairs were made.
