Wetland Delineation Report

Proposed Battery Energy Storage System Site Carver, Massachusetts

AECOM

November 9, 2018

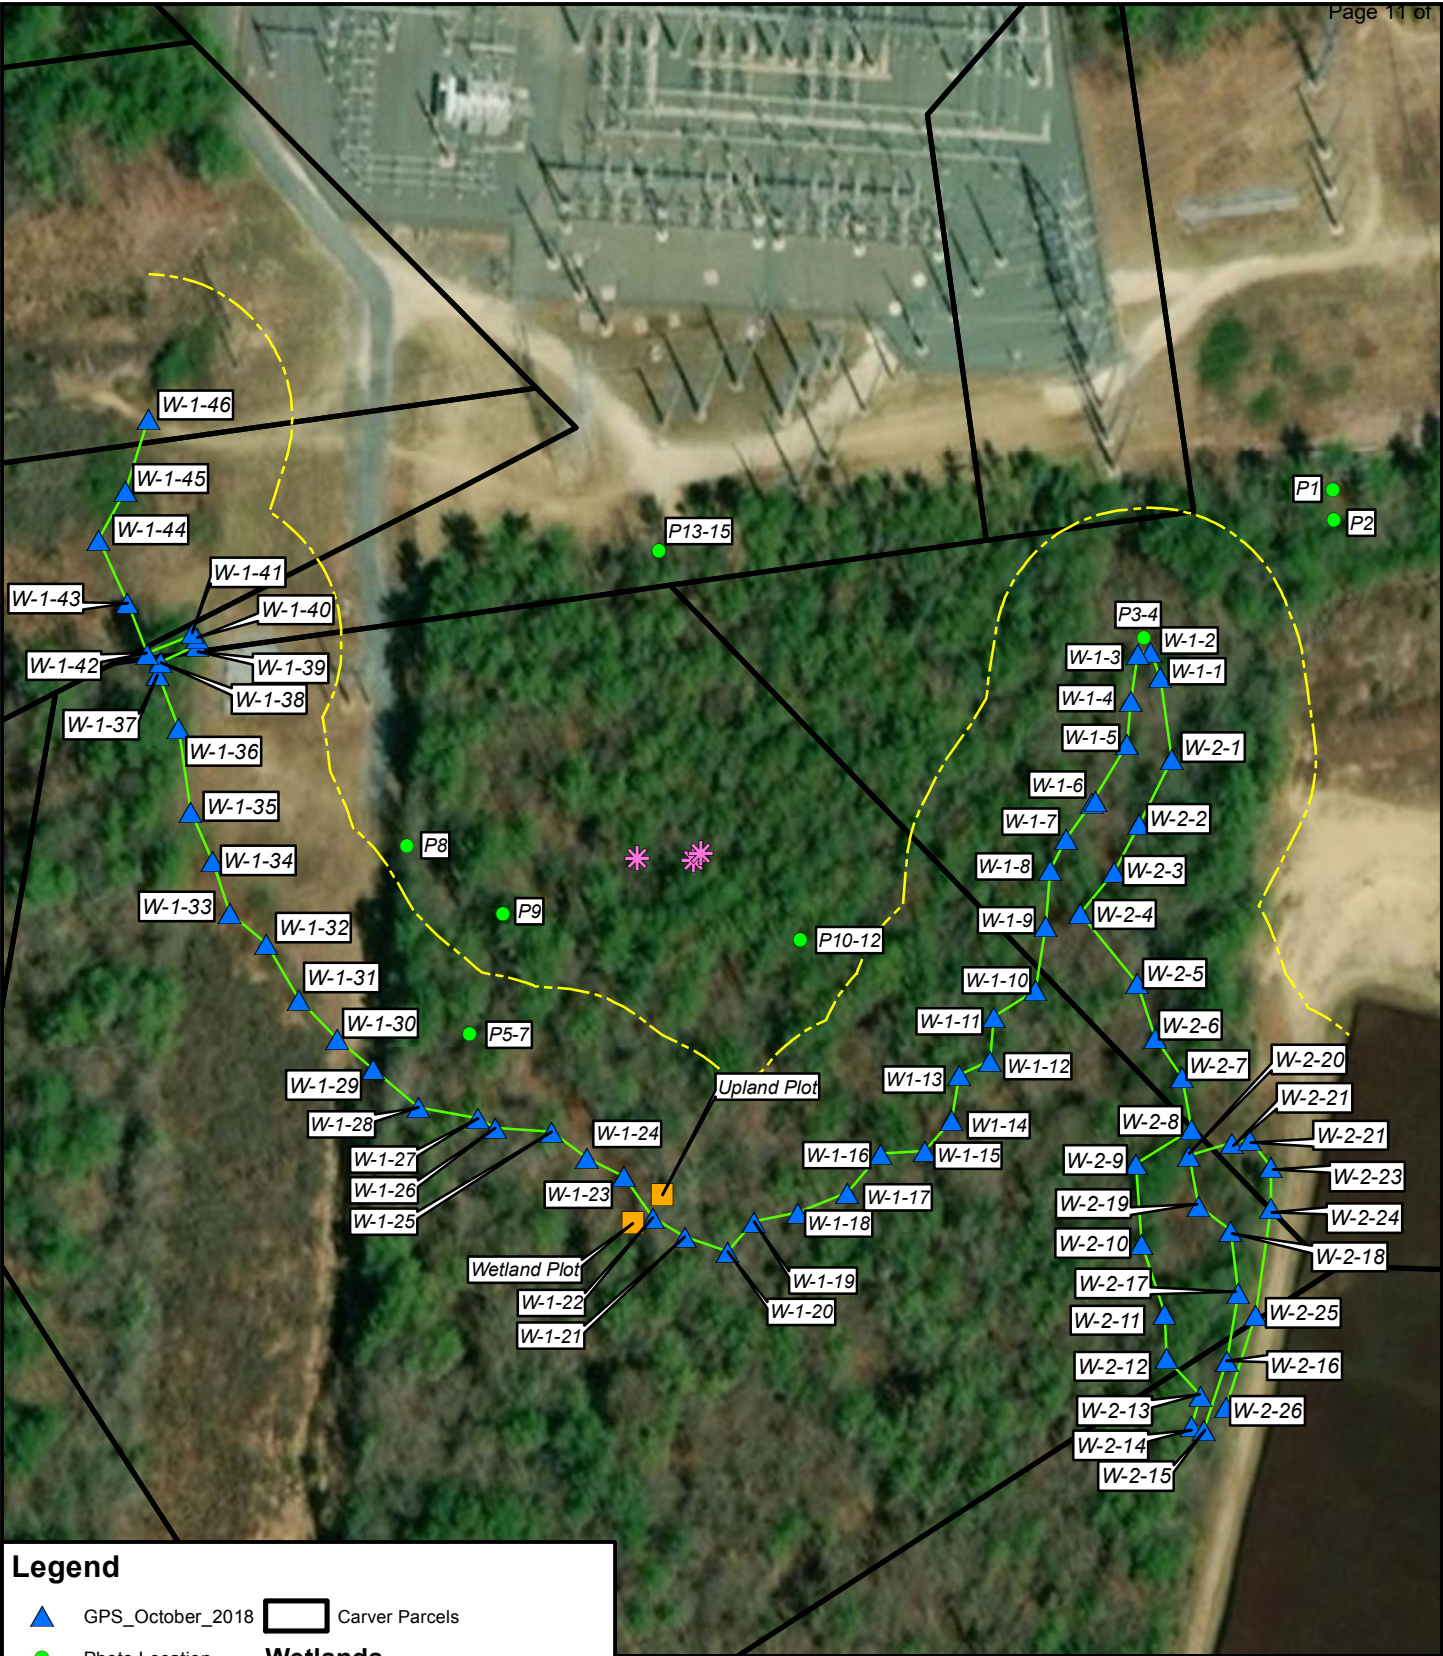
1

Wetland Delineation

Proposed Battery Energy Storage
Site (BESS)
Carver, Massachusetts

A Palustrine Forested (PFO1) wetland (W1) was determined south and east of the proposed BESS site, as noted on Figure 1. Flagging for this wetland included flags W1 (1-28) and flags W2 (1-26) (flagging for the W1 series connects to the W2 series at flags W1-1 and W2-1). A portion of a Palustrine Emergent (PEM)/Scrub-Shrub (PSS) wetland located within two electrical transmission line Rights-of Way (ROW) and an additional PFO wetland located to the east of the proposed BESS site was also delineated. Flagging for this portion of wetland included flags W1 (29-46). All these areas of PFO and PEM/PSS wetland are all contiguous and considered one large wetland area. The proposed BESS site lies partially within the 100-foot buffer zone.

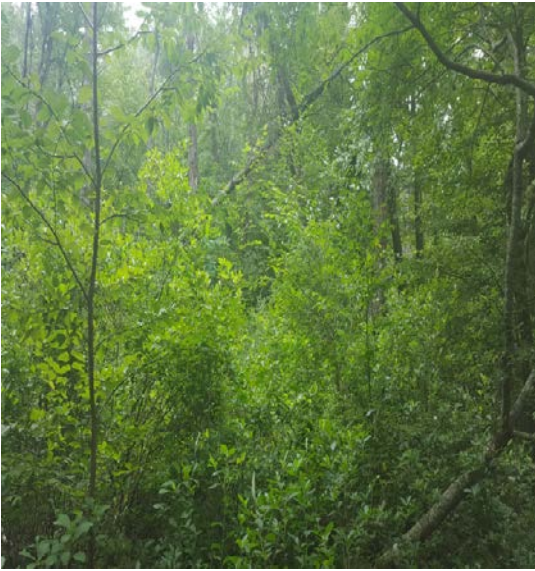
Carver - Area of Wetland Plot

Depth (Inches)	Horizon	Color	Texture	Comments
0-24	Oa	2.5/N (Black)	muck	
24-30+	C	2.5/N (Black)	sand

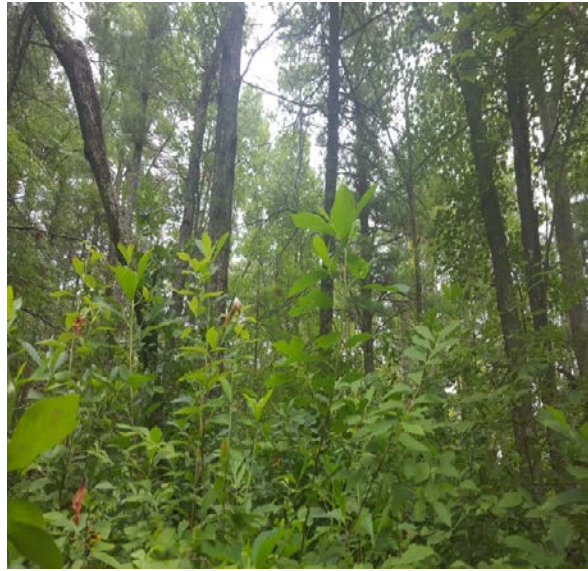
Carver – Area of Upland Plot

Depth (Inches)	Horizon	Color	Texture	Comments
0-2	Oi	10YR 3/3	muck	
2 - 4	A	10 YR 5/1	fine sandy loam	
4-16	B	10 YR 5/8	fine sandy loam	
16-20+	C	10 YR 6/8	fine sandy loam

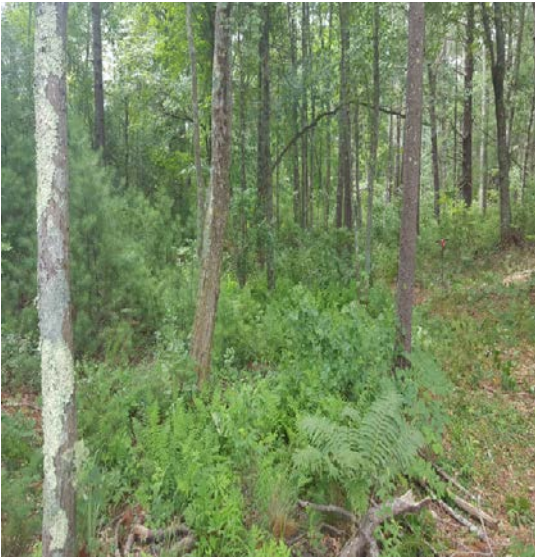
Photo 3: Carver – Tip of Wetland and forested Upland

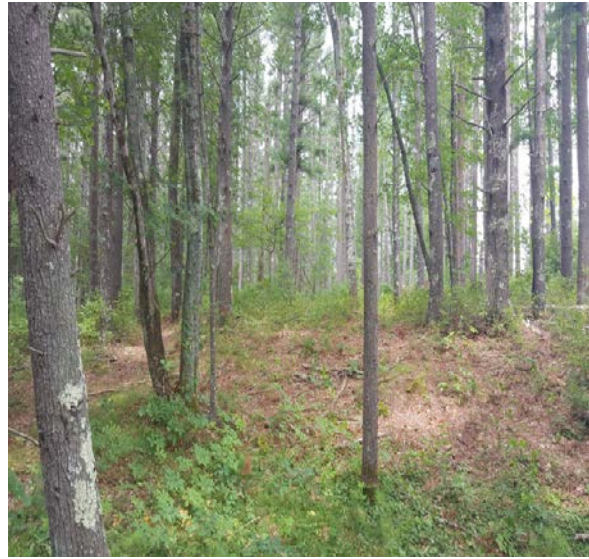
Photo 4: Carver – Tip of Wetland and forested Upland
