Overpressurization of Natural Gas Distribution System, Explosions, and Fires in Merrimack Valley, Massachusetts September 13, 2018

Accident Report

NTSB/PAR-19/02
PB2019-101365

Pipeline Accident Report

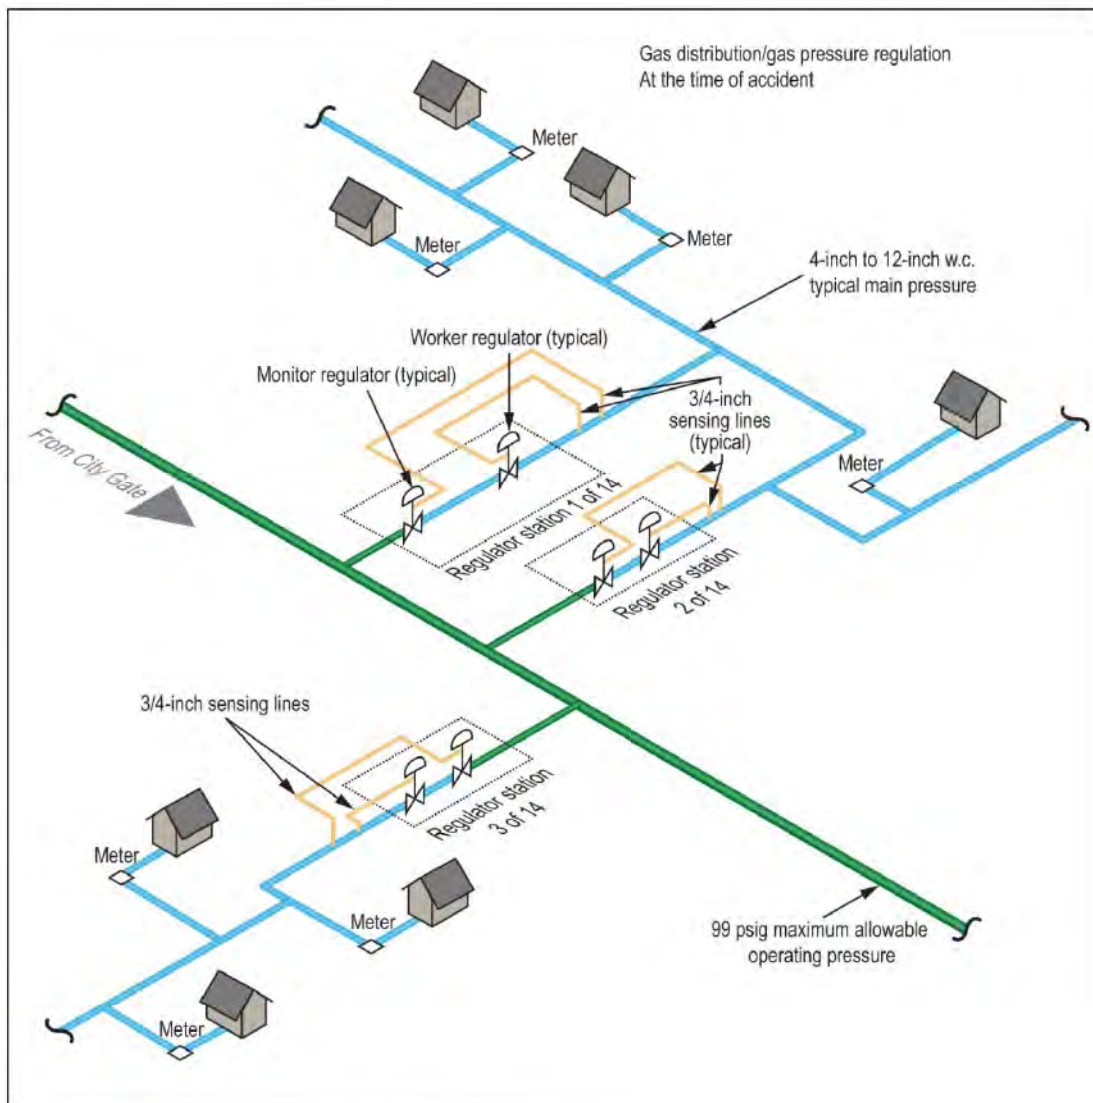
Since the regulator stations are the primary means of pressure control in the low-pressure systems, an overpressure condition in a natural gas distribution system could affect all customers served by the system. This is an inherent weakness of a low-pressure natural gas distribution system.

Figure 3. Typical configuration of the Merrimack Valley low-pressure natural gas distribution system.

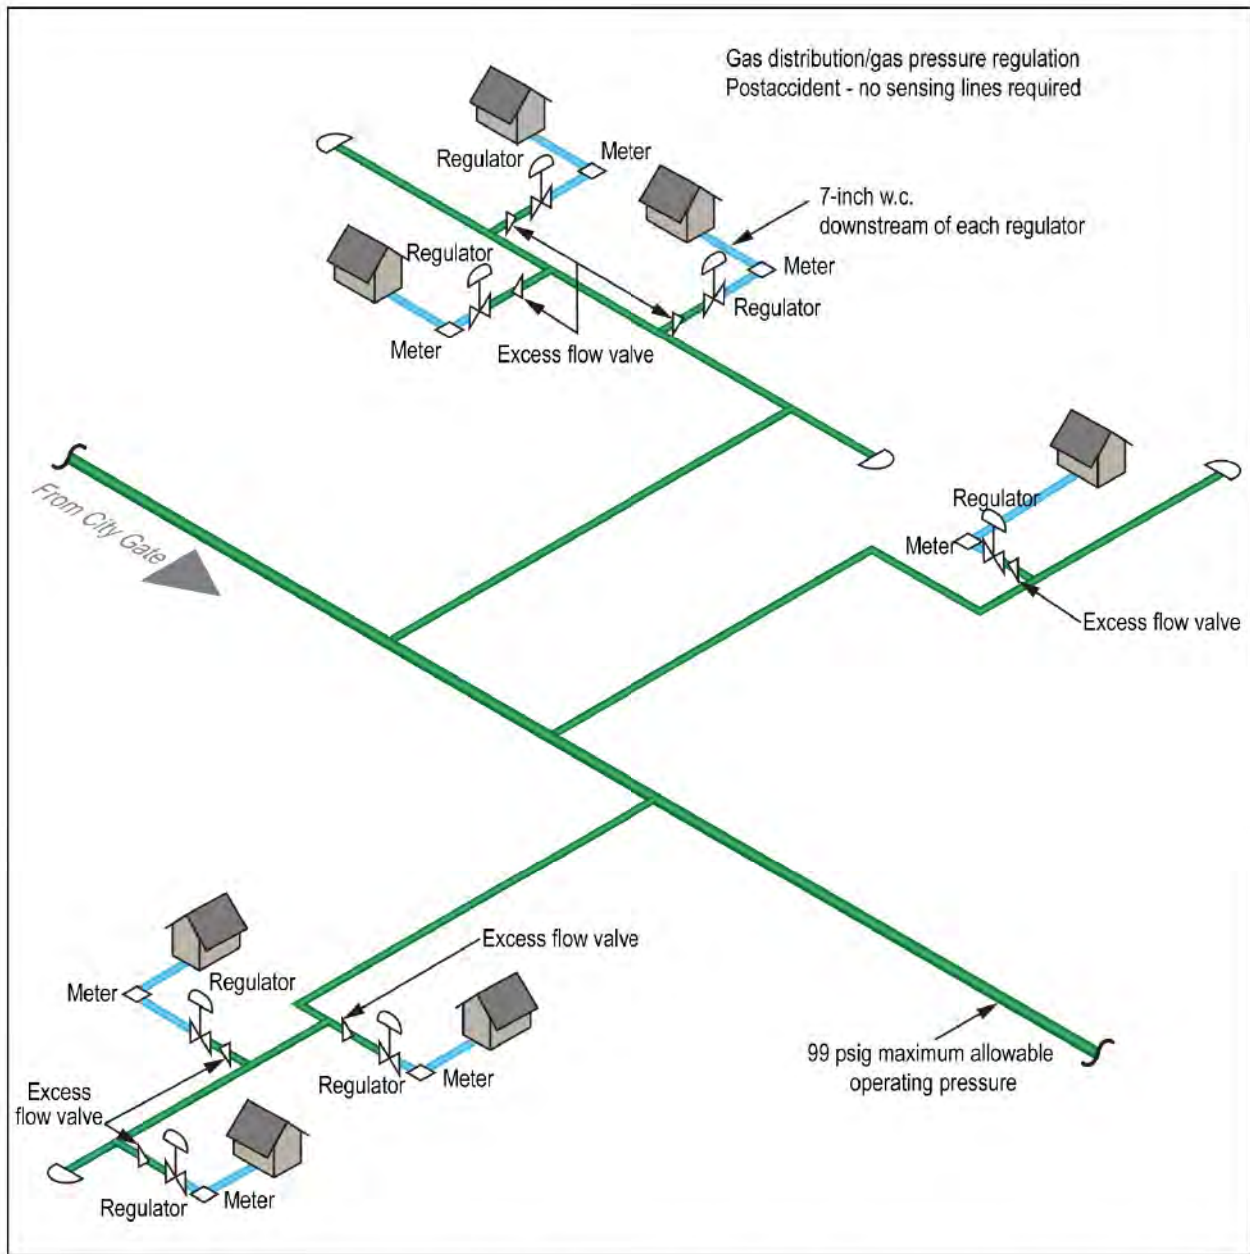
Figure 4. Typical configuration of high-pressure natural gas distribution system installed postaccident.

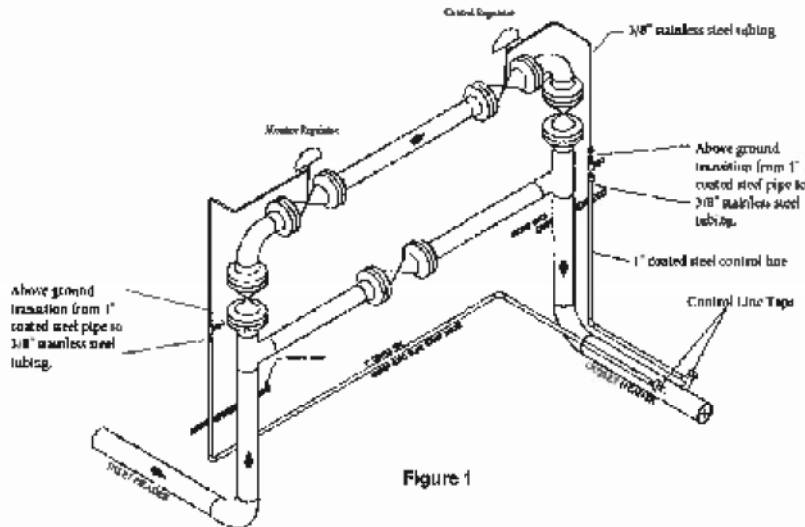
Figure 1 is a schematic drawing showing a regulator setting with control lines extending below grade.

Other lines if damaged, such as telemetry sensing lines and electric lines to equipment at the City Gate/Town Border/POD, District Plant Regulator or Customer M&R station, may also result in pressure monitoring and control issues, which may lead to a catastrophic event.
