D.P.U. 24-40 **Eversource Energy** 2023 Grid Modernization Report Attachment C Page 1 of 13

System Operation Post-Commissioning

Reliability Improvement

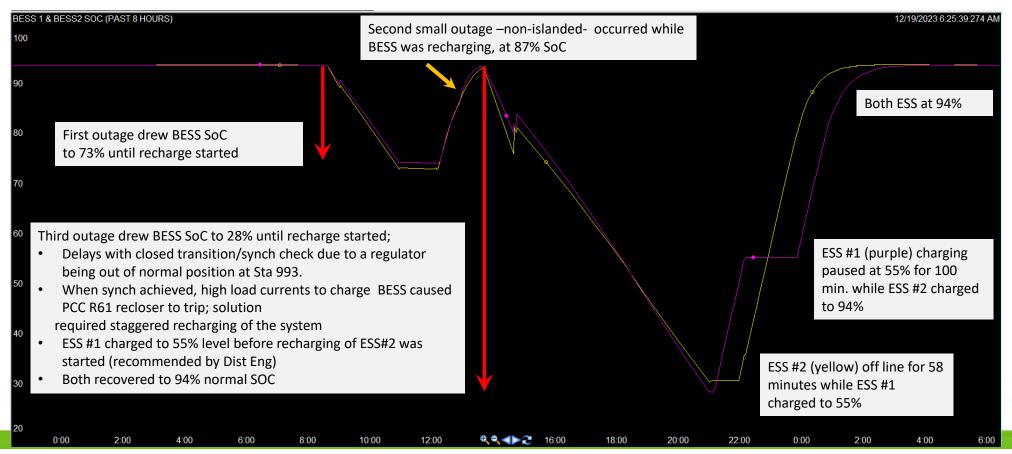
BESS Charge levels Surrounding Island Events 1 and 3

BESS discharged from 95% to 28% Delays in synchronizing did not extend outage beyond 6 hr, 49 min repair time needed, but BESS SoC continued to drop.
